**Project no: 402828**  
**Roads Materials Supply Strategy**

**Botanical Sensitivity Analyses for Proposed Borrow Pit**

DR2310/28.9/0.02L Beaufort West

**2015.03.28**

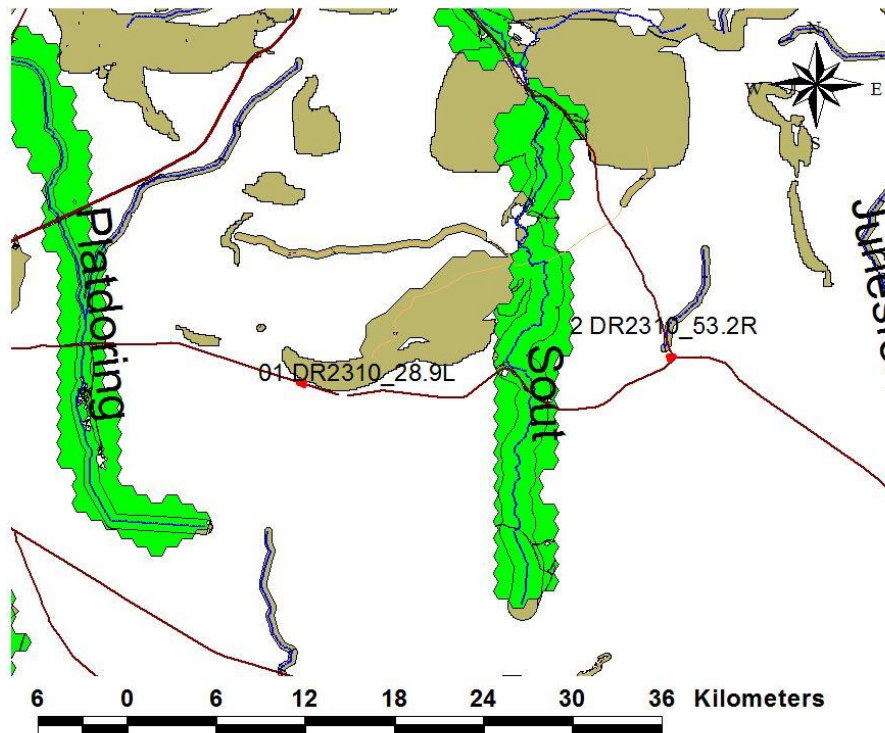
**Figure 1. Proposed borrow pits (red dots) in relation to Critical Biodiversity Areas (CBA light green), and ecological support areas (brown) mapped for the Central Karoo District Municipality (Skowno 2009)**

The vegetation of the application area is Gamka Karoo (NKI1), a largely untransformed vegetation type that has Least Threatened status (Rouget et al. 2004). The proposed borrow pit is NOT in a Critical Biodiversity Area, Ecological Support Area (Skowno 2009, **Figure 1**), nor in a Freshwater Ecosystem Priority Area (WRC 2011, **Figure 2**). Mean annual rainfall is between 200 and 400 mm/year.

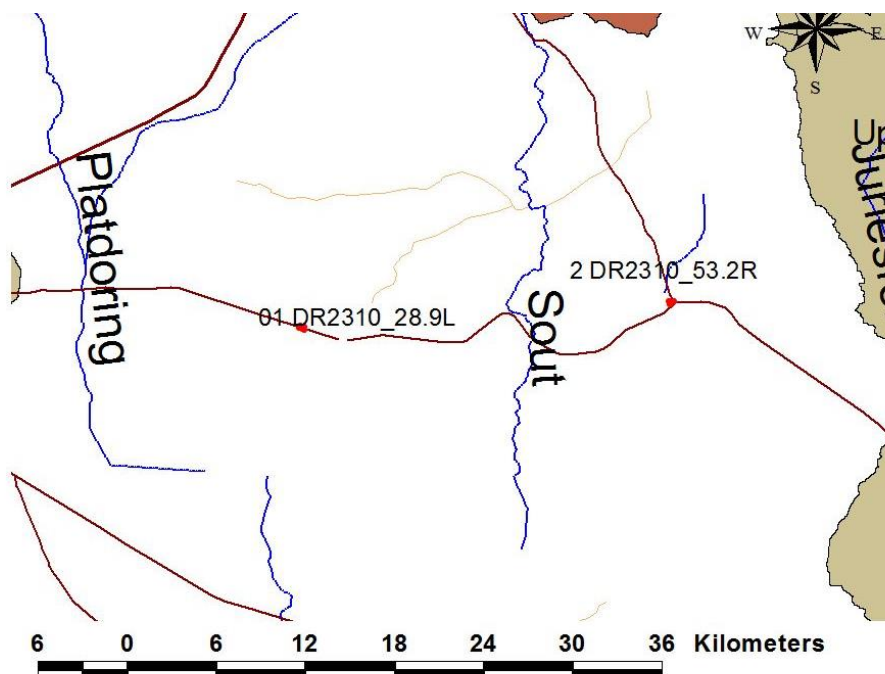
**Figure 2. Proposed borrow pit (red dots) in relation to Freshwater Ecosystem Priority Areas (dark brown) and upstream areas (light brown) as defined by WRC (2011)**

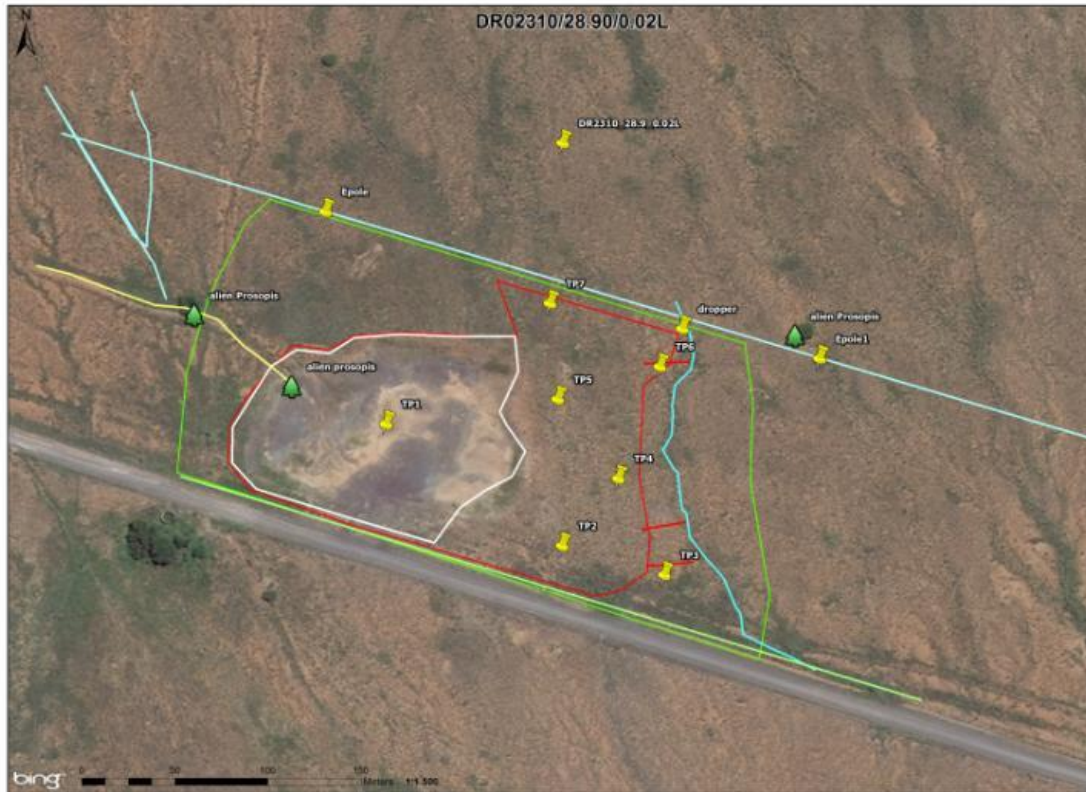
The application area (4.2 ha) includes an existing 1.0 ha borrow pit adjacent to the DR2310 on private land presently used for small stock farming (**Figure 3 & 4**). About 25 % of the vegetation within the application area has been disturbed by previous gravel mining. The BP extension will remove an additional 1.9 ha (50%) of indigenous vegetation. Soils are shallow and silty, and overlie Beaufort series mudstone. Runoff from the dolerite-capped ridge to the north drains southwards

Figure 3. Application area (green polygon) in relation to the divisional road, drainage lines (blue), existing borrow pit (white outlined), proposed preferred resource (red outline) and man-made canal (yellow line to west) invaded by *Prosopis* trees

1. Fence out borrow pit to contain movement of people and vehicles;
2. Fell all *Prosopis* (mesquite/meskiet) trees along the inlet furrow to the west of the existing BP, and fell the large tree to the north east of the BP. Remove all branches and seed pods and dispose of at an official/ licensed waste disposal site;
3. Set back the proposed BP 20 m from the dry drainage line that runs southwards through the eastern third of the investigated area;

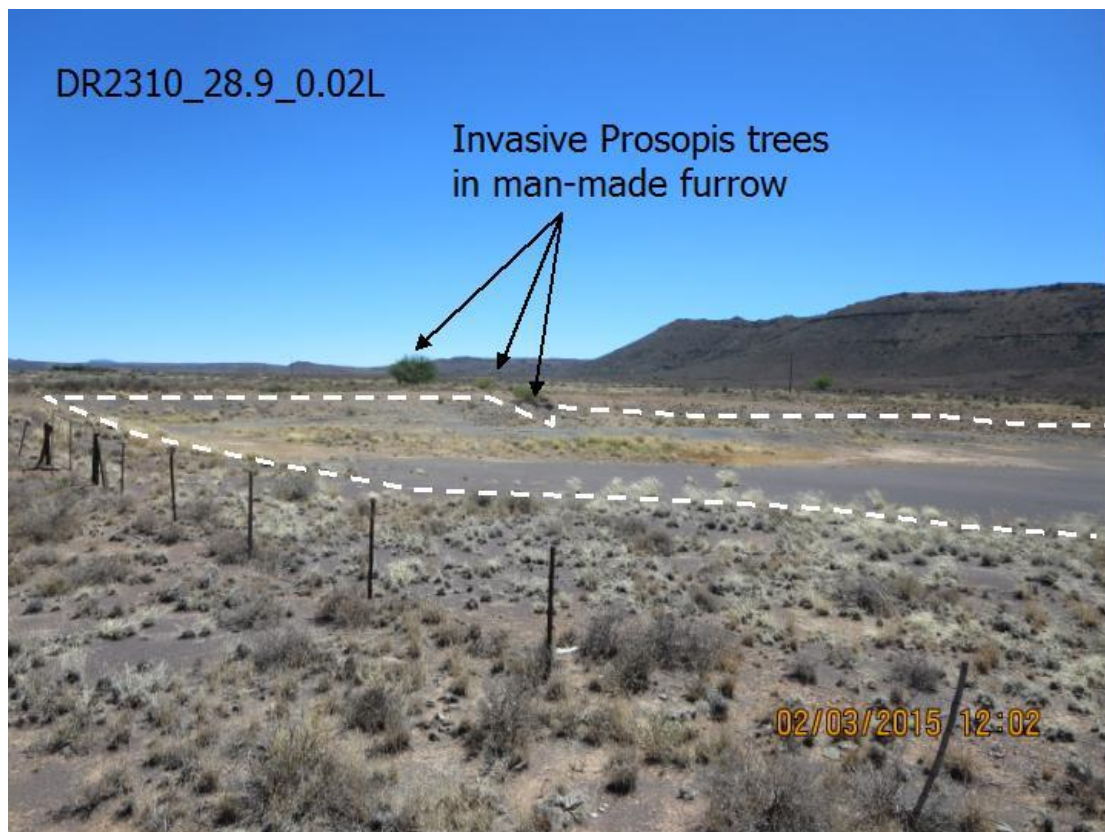
towards the road (**Figure 4**). A small drainage line crosses the eastern part of the application area.

**Figure 4. Existing borrow pit (dashed white line), invasive *Prosopis* trees, and dolerite ridge to north of the site**

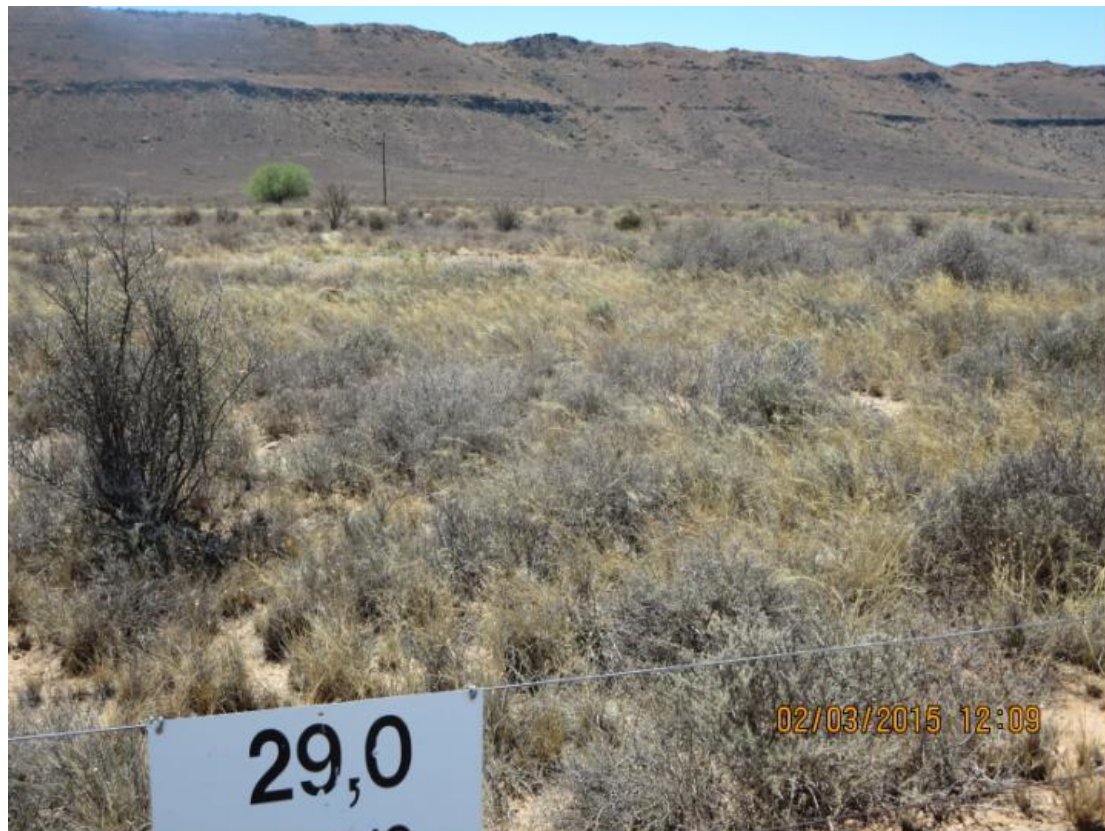
The vegetation on the proposed borrow pit application area comprises a mixture of grasses and succulent and non-succulent shrubs. The dominant species is *Pentzia incana* (ankerkaroo). The vegetation is denser in the south-eastern corner of the application area that benefits from runoff from the ridge to the north (**Figure 5**).

**Figure 5. The densely-vegetated south-eastern corner of the application area showing the mix of grasses and Karoo shrubs**

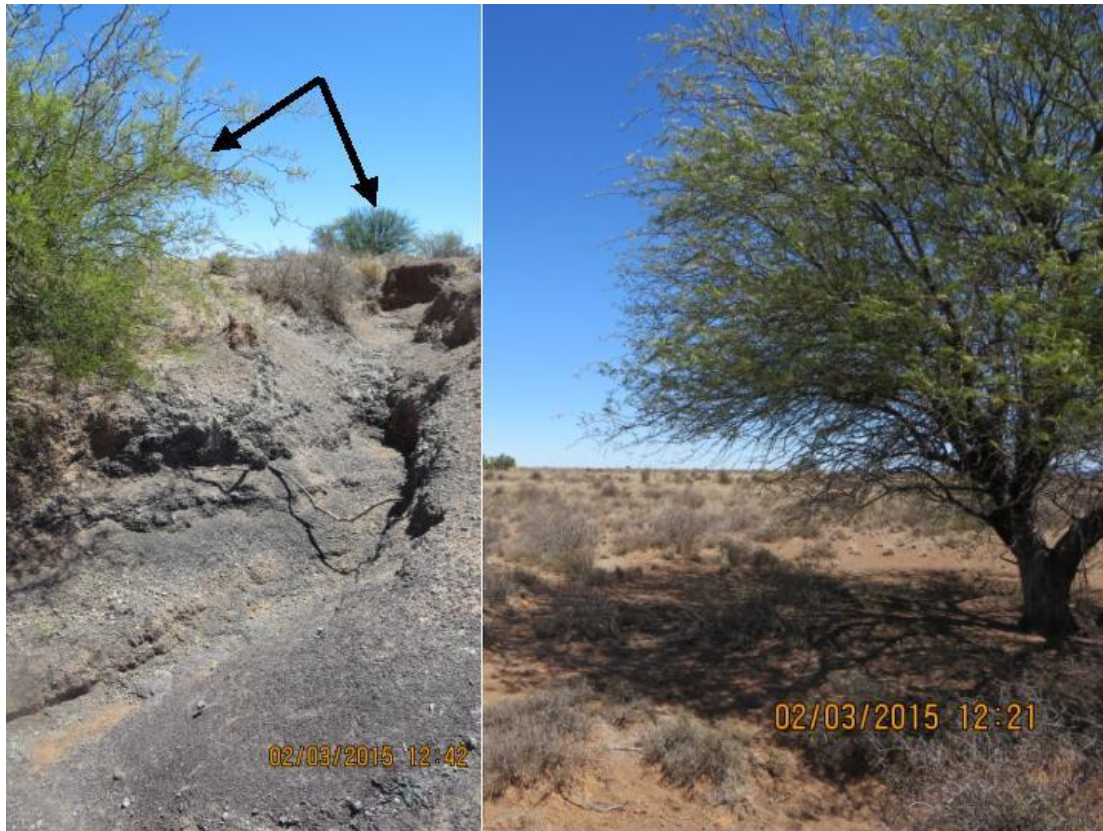
Of the 29 indigenous plant species recorded from the site, four are protected in the Western Cape but none of these is a threatened Red Listed species (**Appendix 1**). Invasive alien plants recorded on the site were *Prosopis* sp (mesquite) and *Salsola kali* (rolbos). Most of the *Prosopis* trees and saplings recorded were associated with a man-made furrow in the western region of the investigated area which leads water from the hillside into the existing BP (**Figure 6**).

**Figure 6. Invasive alien *Prosopis* sp (Mesquite) trees to the north of the proposed borrow pit extension area and along a man-made canal leading water from the hillside into the west side of the existing BP**

12. Shape the walls of the BP at a shallow enough angle (not steeper than 1:3) to hold soil and plants;
13. Prevent inundation of the borrow pit depressions as this prevents establishment of Karoo vegetation and affects runoff to rivers. The pit must be free draining. Divert water into established vegetation or into the drainage line in the eastern section of the investigated site area. Close the furrow leading water into the BP from the west;
